**Cost Reductions  
and  
Product Consistency  
Improvements  
Using Unannealed  
High- Frequency/Solid State  
(UHFSS) Welded 409 Stainless  
Steel Heat Exchanger Tubing**

**Edward D. Basta, Senior Metallurgical Engineer  
Atlas Steel Products Co.  
7990 Bavaria Road  
Twinsburg, OH 44087  
USA**

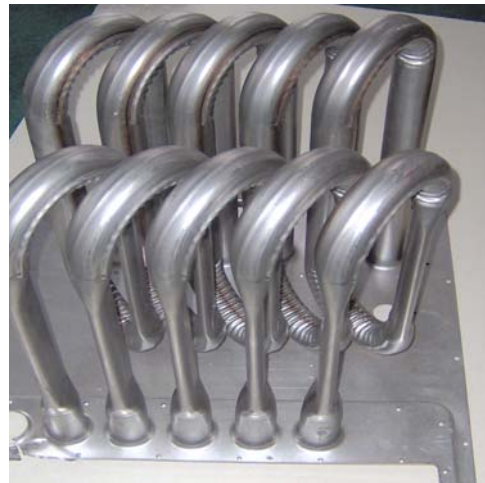
Commercial and residential HVAC systems have evolved over the years from using predominantly "clamshell" heat exchanger components to the more efficient and cost effective tubular heat exchanger. Figure 1 shows a typical tubular heat exchanger unit.

Figure 1: Tubular Heat Exchanger

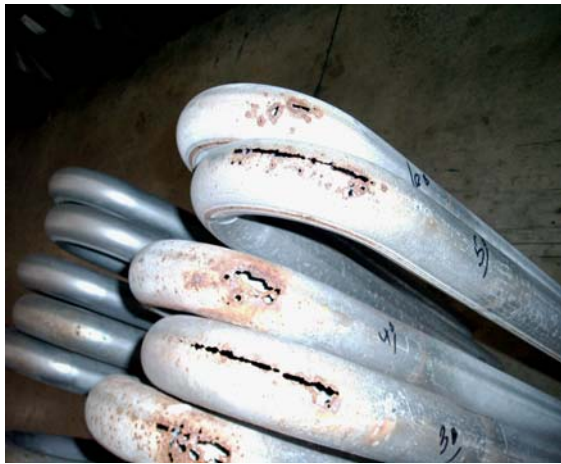
Figure 2 shows a view of a commercial rooftop heat exchanger unit that had been replaced after only six years of service. The severe surface oxidation is evident on the weld seams and in other areas that have suffered coating diffusion due to heating above the diffusion temperature. The coating diffusion is evidenced by the lighter/whitish aluminum oxidation and a darker gray surface coloring.

*Figure 2: Corroded Aluminized Steel Heat Exchanger*

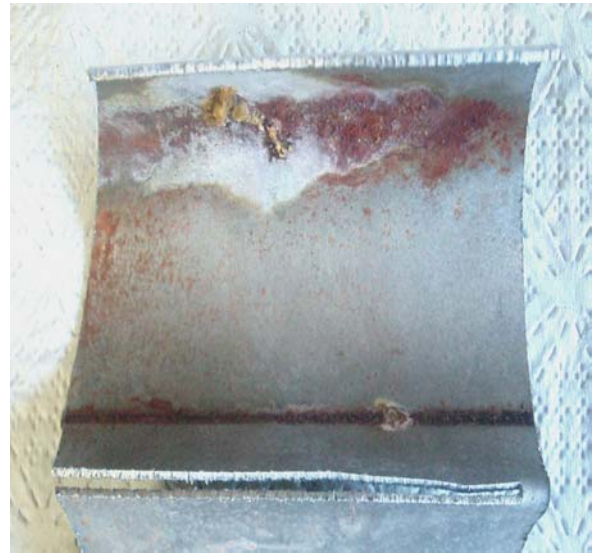
Figure 3 shows an I.D. view of a section of this aluminized steel heat exchanger tube section that was cut from the heat exchanger unit. A heavy layer of corrosion is visible on the inside surface. The tube's I.D. weld seam is noted below the corroded area.

*Figure 3: Oxidized Aluminized Steel Tube I.D. Section*

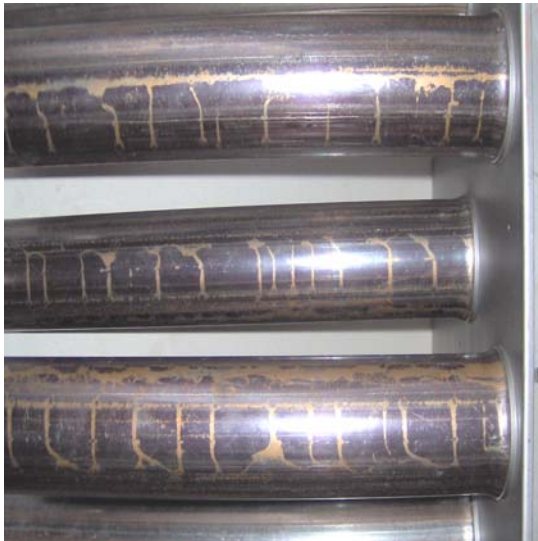
One disadvantage of the post-weld annealing/stress relieving process for laser welded 409 stainless steel heat exchanger tubing is the significant and varying surface discoloration that the heat treatment step causes. Since the tube is typically heated in the open air, not in an atmosphere-controlled furnace, the surface of the laser welded 409 stainless steel tubing usually develops a darker surface oxide hue ranging from a medium copper color to a very dark brown color, often with lighter streaks usually caused by dripping tube mill coolant. Figures 7 and 8 show views of these discoloration conditions.

*Figure 7: Dark and Streaky Surfaces of Laser Welded and Annealed Tubing*

Heat exchanger tube bending personnel have also found that the different hues of the surface discolorations in annealed 409 stainless steel tubing can foreshadow significant variations in the abilities of the different tubing to be bent to final configurations. In some cases, laser welded and annealed tubing with a very light copper color was much more difficult to bend than tubes with darker-hues. It is hypothesized that the difference in coloring corresponds to variations in the annealing/stress relieving temperature actually achieved by the tubing during the annealing process.

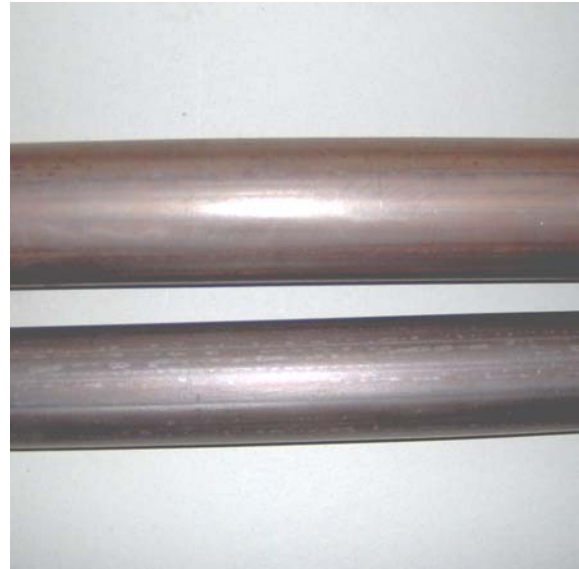
*Figure 8: Varying Degrees of Surface Staining/Coloring in Laser Welded and Annealed Tubing*

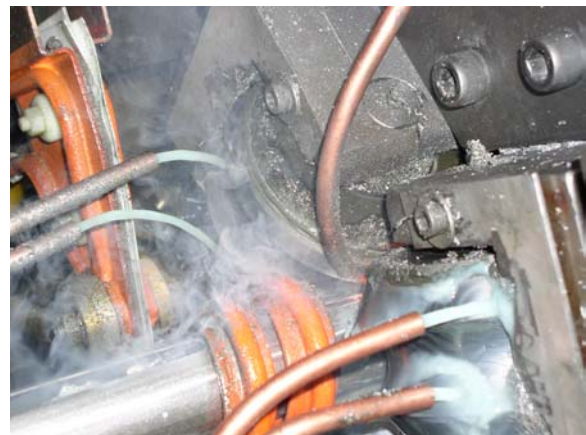
UHFSS tube welding mills generally run at much higher speeds than either TIG or laser welding tube mills, usually in the 150 to 220 fpm range, depending on the O.D. size and wall thickness of the tube being produced. The high frequency solid state welding systems used are typically much less complicated than TIG or laser systems, and are easier to maintain and change over. The advent of variable power (adjustable kW) high frequency heating systems has also allowed significant improvements in stainless steel weld qualities vs. older "single kW" power systems. Figure 9 shows a basic view of a typical high frequency/solid state tube mill's weld box area.

*Figure 9: UHFSS Coil and Weld Box Area*

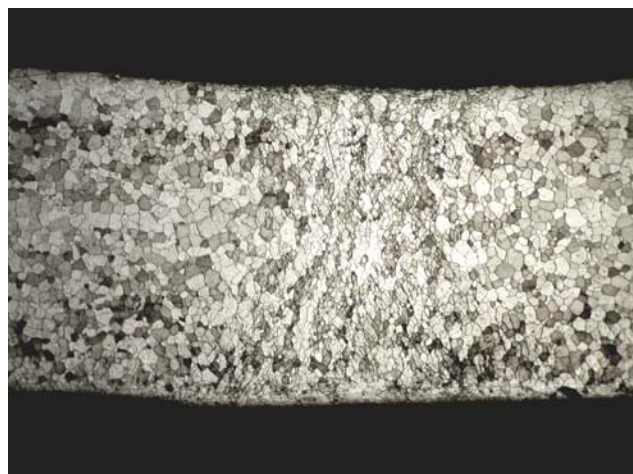
The UHFSS tube weld is vastly different than either TIG welding or laser welding in the 409 stainless steel material. As seen in Figure 10, the weld zone and HAZ is almost indistinguishable from the base material of the tube wall. This maintenance of a generally fine-grained equiaxed microstructure in the ferritic stainless alloy means that the resulting weld will be stronger and less prone to fatigue failure. The need for a post-welding anneal or stress relieve has been virtually eliminated due to this resulting uniformity in the weld zone.

*Figure 10: Typical UHFSS 409 SS Tube Weld Zone/HAZ*

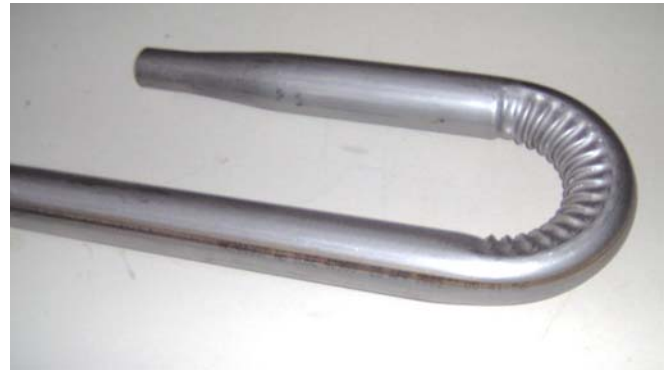
*Figure 15: Wrinkle-bent and "pointed" U-bend tube*

This is due to fewer setup changes and/or mid-shift adjustments being required to the bender when a new lot of tube is loaded in the machine. It is not uncommon for a tube bender to need significant adjustments each time a new load of annealed tubing is started. Tests have shown that the properties of the as-welded 409 stainless tubing are much more consistent than those of multiple annealing lots, even when made from the same heat of raw material. Figures 12 through 15 show just a few of the many difficult bending configurations where UHFSS welded 409 stainless steel heat exchanger tubing has been successfully used.

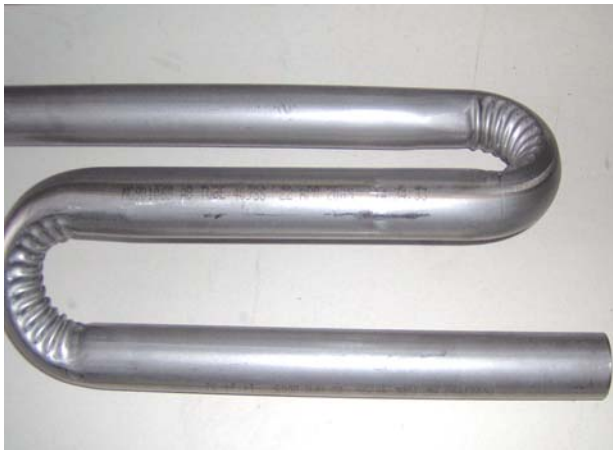
*Figure 13: Serpentine Wrinkle-bent tube*

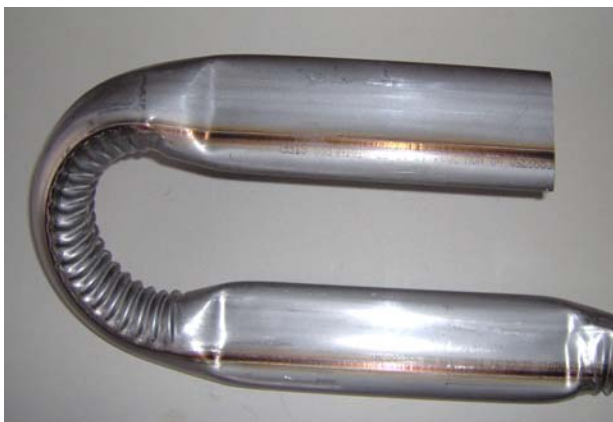
*Figure 14: Wrinkle-bent and flattened tube*
